## **Corrosivity of Peroxyacetic/Nitric Acid Solution from Reflex® on Chrome**

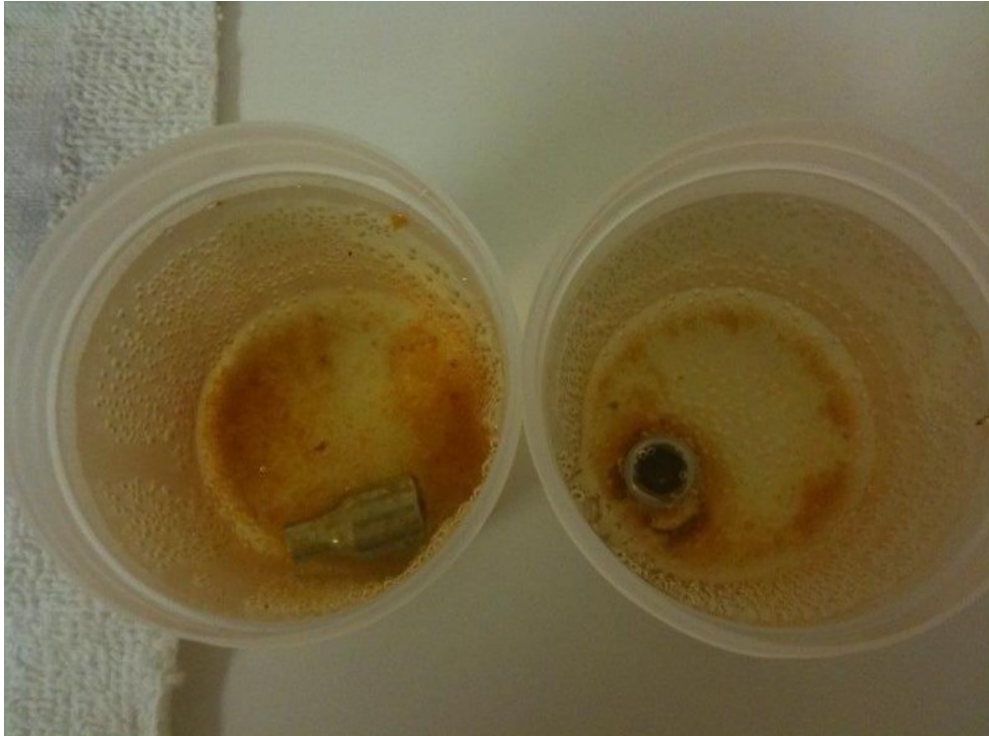
Throughout the seven-day experimental period, the solutions in both sample cups containing the two sockets were visually observed for signs of corrosion. Image 1 was taken on Day 1 and it shows that there was certainly corrosion occurring but upon

microscopic examination of the chrome sockets themselves, it appeared that only the inside unplated mild steel metal of both chrome sockets had been attacked. The orange-brown coloration and debris was a result from corrosion of the underlying metal, which could be an indication of mild steel or other reactive metals present. It is known that PAA and nitric acid are a corrosive agent to these types of metals. These observations can be seen in Tables 1 and 2.

- Both sockets showed interior signs of corrosion throughout the seven day experimental period. However, microscopic examination indicated that corrosion only occurred where the underlying mild steel was exposed, including engraved areas on the chrome plating where the PAA solution came into contact with that reactive metal unprotected by the chrome.

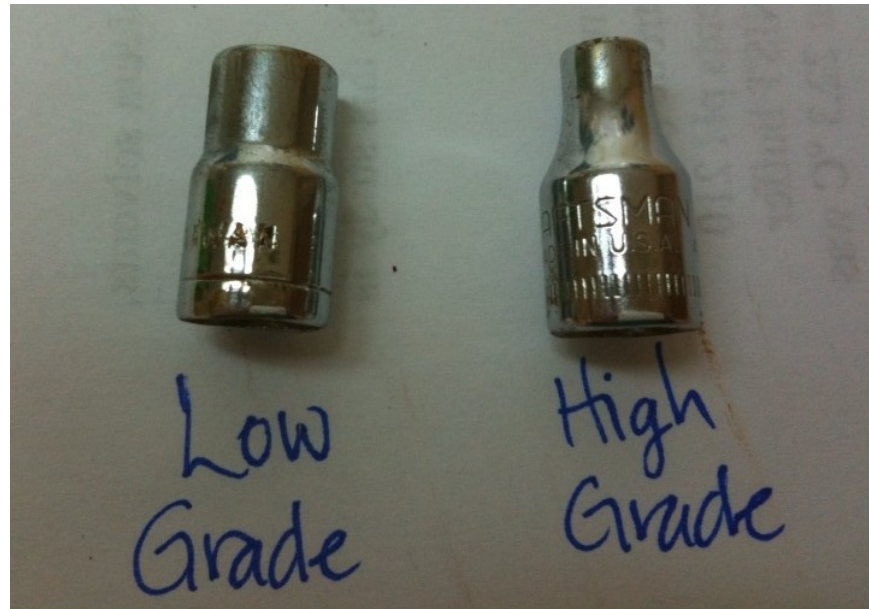
Although the solution of both the low grade chrome socket and high grade chrome socket turned to an orange-brown color throughout the seven day experimental period, only the low grade chrome socket showed signs of corrosion on the chrome plating itself, after the first day and continued to worsen throughout the seven day period.. The chrome plating covering the outside of the high grade chrome socket remained intact for the first part of the experiment but by Day 7, one small corrosion spot appeared. The corrosion areas present on the chrome of both sockets were located only where there were engraved grooves exposing the underlying mild steel and subsequently allowing contact with PAA solution. Image 2 shows both the low grade and high grade chrome sockets after being exposed to the 100 ppm PAA solution for seven days. These observations can be seen in Tables 1 and 2.
