Corrosivity of 2,2-dibromo-3-nitrilopropionamide (DBNPA) in Direct Contact with Mild Steel, Stainless Steel, and Zinc Coupons

07/22/2013

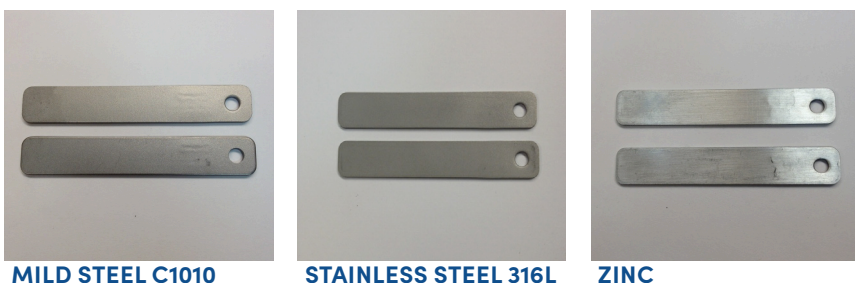
FIGURE 1 Metal coupons prior to contact with the DBNPA test material. Metals tested were mild steel (C1010), stainless steel (316L), and zinc.

Enviro Tech's **Enviro Brom** Tabs contain approximately 95% active DBNPA. Two metal coupons with a nominal size of 3" x 1/2" were obtained for each of mild steel (C1010), stainless steel (316L), and zinc. Each set of coupons was thoroughly washed with mild detergent and water, dried, and then rinsed with acetone to remove any residual oils. The exact dimensions of each coupon were measured using a caliper, and each coupon was weighed on an analytical balance. The three pairs of coupons were placed in three different pails each containing 5 gallons of Modesto city water at ambient temperature. The two coupons were placed side-by-side in each bucket but were separated with a 3 mm plastic rod to prevent the two metal coupons from coming into contact. A 100 gram **Enviro Brom** Tab was placed directly on top of the coupons so both coupons were equally covered. Each of the three pails were covered and allowed to sit undisturbed for 30 days, the concentration of DBNPA in each pail being measured on a weekly basis using the Palin modification of the DPD method.

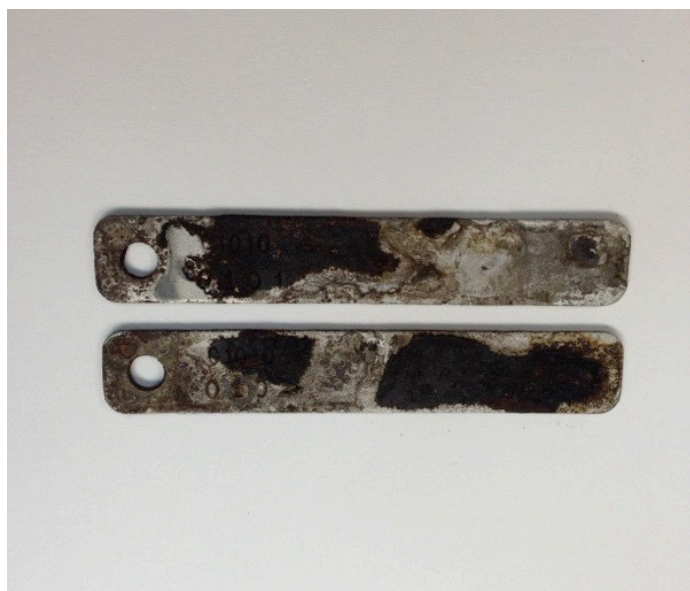
MILD STEEL C1010

FIGURE 3 Final cleaned coupons after 30 day contact time with the DBNPA test material.

■ DBNPA was most corrosive towards the mild steel (C1010). The high corrosion rate of 28.23 mpy indicates that this may not be an appropriate material for contact with DBNPA. This study represents a worst-case situation in which the solid DBNPA remains in direct contact with the metal. In situations where DBNPA is suspended above the metal, or only dilute solutions contact the metal, a lower corrosion rate would be expected.
