Corrosivity of 2,2-dibromo-3-nitrilopropionamide (DBNPA) in Direct Contact with Mild Steel, Stainless Steel, and Zinc Coupons

06/22/2013

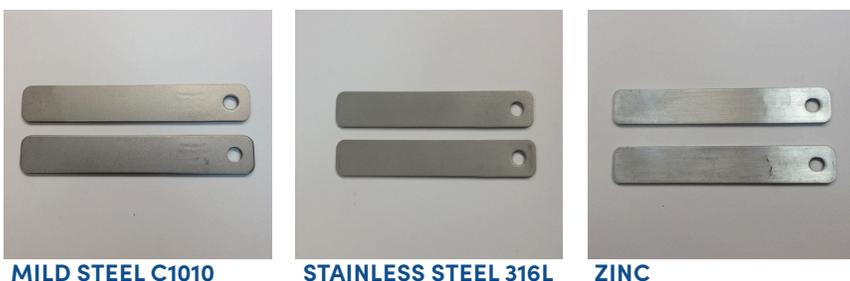
FIGURE 1 Metal coupons prior to contact with the DBNPA test material. Metals tested were mild steel (C1010), stainless steel (316L), and zinc.

Enviro Tech's **Enviro Brom** Tabs contain approximately 95% active DBNPA. Two metal coupons with a nominal size of 3" x 1/2" were obtained for each of mild steel (C1010), stainless steel (316L), and zinc. Each set of coupons was thoroughly washed with mild detergent and water, dried, and then rinsed with acetone to remove any residual oils. The exact dimensions of each coupon were measured using a caliper, and each coupon was weighed on an analytical balance. The three pairs of coupons were placed in three different pails each containing 5 gallons of Modesto city water at ambient temperature. The two coupons were placed side-by-side in each bucket but were separated with a 3 mm plastic rod to prevent the two metal coupons from coming into contact. A 100 gram **Enviro Brom** Tab was placed directly on top of the coupons so both coupons were equally covered. Each of the three pails were covered and allowed to sit undisturbed for 30 days, the concentration of DBNPA in each pail being measured on a weekly basis using the Palin modification of the DPD method.

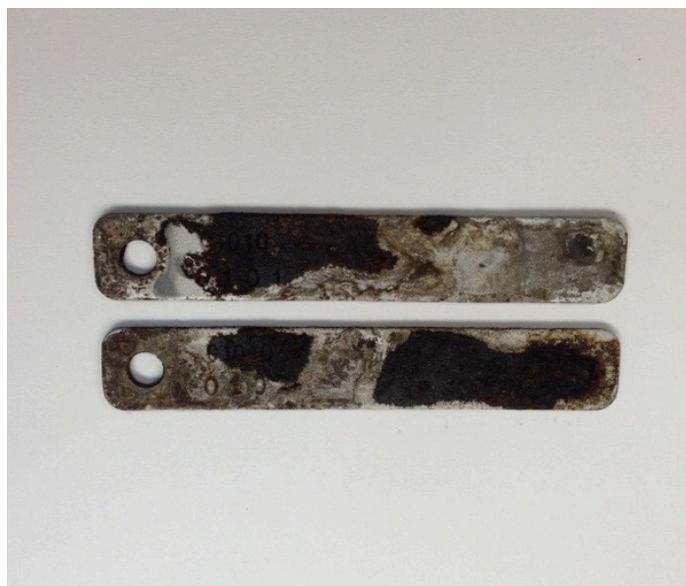
MILD STEEL C1010

FIGURE 3 Final cleaned coupons after 30 day contact time with the DBNPA test material.

- Mild steel C1010 corrosion rate of 28.23 mpy
- Stainless steel 316L corrosion rate of 0.00 mpy
- Zinc corrosion rate of 5.58 mpy

■ DBNPA was most corrosive towards the mild steel (C1010). The high corrosion rate of 28.23 mpy indicates that this may not be an appropriate material for contact with DBNPA. This study represents a worst-case situation in which the solid DBNPA remains in direct contact with the metal. In situations where DBNPA is suspended above the metal, or only dilute solutions contact the metal, a lower corrosion rate would be expected.
